**AVIATION INVESTIGATION REPORT
A12P0136**

COLLISION WITH TERRAIN

**PIPER PA-30 TWIN COMANCHE C-GLGJ
KELOWNA, BRITISH COLUMBIA, 18 NM W
13 AUGUST 2012**

Report Number A12P0136

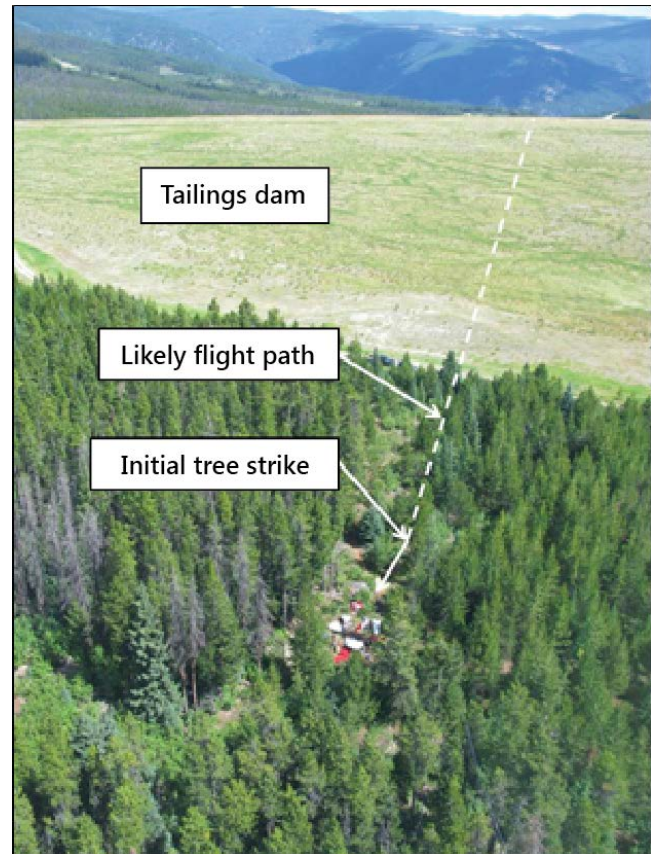
The aircraft crashed on a level, treed portion of the Brenda Mines tailings dam, about 0.7 nm southwest of Highway 97C (Photo 1), at an elevation of 4595 feet asl. Though not a published VFR route, Highway 97C follows the Trepanier Creek Valley and is often used by pilots as a route when flying west from the Okanagan Valley. The Brenda Mines site is about 10 nm north of the published VFR route from Summerland to Princeton, and the valley southwest from the Brenda Mines to the published VFR route is the logical low-ground route between the two (Figure 1).

The terrain before the treed area at the accident site is a level, grass-covered area atop the Brenda Mines tailings dam (Photo 1). Based on the aircraft's path as it struck the trees, its likely flight path took it over about 1600 feet of unobstructed grass and about 200 additional feet of forest, before it contacted the first tree. Trees immediately past the accident site, as well as those to the right of it, were about twice as tall (about 70 feet) as the trees that were overflown (about 35 feet) and struck. A parallel flight path at the same altitude, but about 1000 feet to the left, would have been over ground low enough to clear the trees at this altitude and to then have continued to Princeton.

After striking the first of 5 small trees, the aircraft travelled about 75 feet, before coming to rest. Leading-edge damage indicated that the aircraft struck the trees while banked about 45°, right-wing low. Impact with the trees and ground separated the outboard 6 feet of both wings and broke the fuselage into 3 pieces, but the aircraft remained upright. The flaps and landing gear were found fully retracted. Both propellers sustained light scoring and leading edge damage, as well as heavy bending damage.

Photo 1. Aerial view of the accident site, showing the likely flight path before the initial tree strike
